Tesoro Refining and Marketing Company LLC v. Pacific Gas & Electric Company,

Expert Report of Brian Rahman, ZGlobal, Inc.

Supplemented

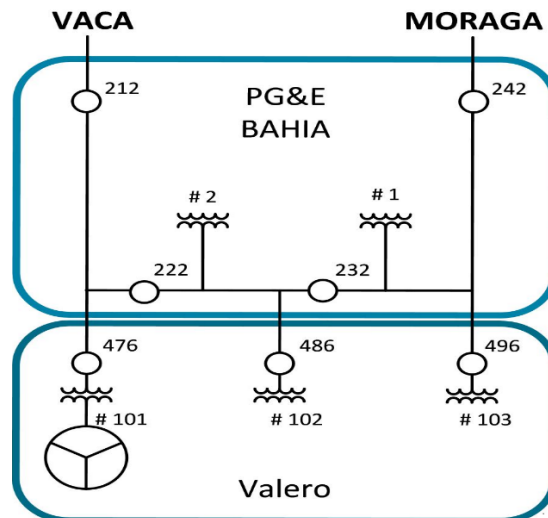
The diagram above is a simplified depiction of the PG&E Bahia and Valero (Customer) 230 kV substation configuration. SPS is used to prevent electrical islanding to PG&E Bahia load and Valero generation. To prevent islanding at Bahia PG&E has implemented the following:

1. When both Bahia Circuit Breakers 212 and 242 (line side breakers) are open, all high side Valero Circuit Breakers 476, 486, and 496 will open and lockout. (Lockout is a state in which the circuit breakers will not attempt to automatically re-close).
2. When 230 kV bus voltage at Bahia drops below 15 kV (or approximately 6.5% of normal), all high side Valero Circuit Breakers 476, 486, and 496 will open and lockout

Given the SPS for Valero, I believe PG&E understood the impacts of islanding at substations such as Tidewater. PG&E had advanced knowledge of electrical configuration and associated load but failed to take actions to prevent the situation identified by their own operations engineer. But PG&E did not share the islanding risk with Tesoro or Foster Wheeler – or this potential solution to it – prior to the November 10, 2010 outage. Instead, PG&E waited until after the outage to suggest that a special protection scheme be installed.

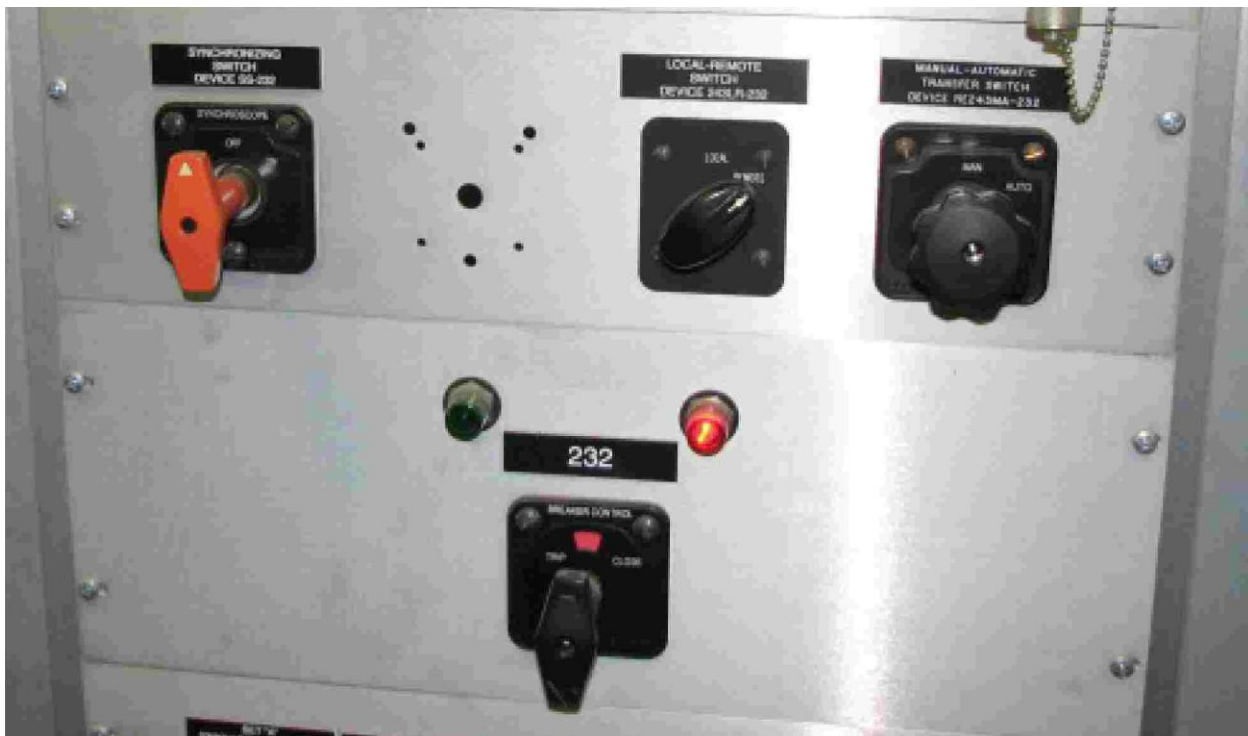
(PG&E00026696 - Tidewater CB 232 Control Panel at Tidewater. Note: synch switch has key, with red removable handle in left hand side of picture).

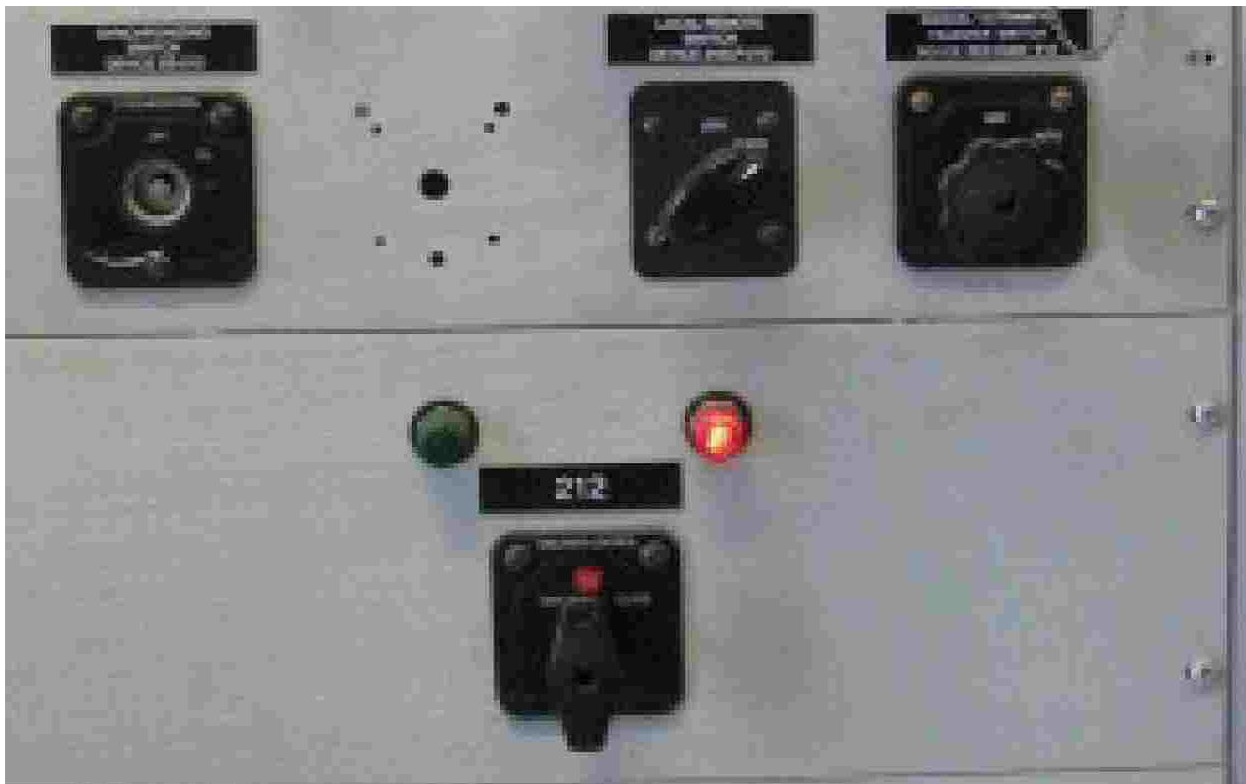
(PG&E 26694 - Circuit Breaker 212 Control Panel at Tidewater Substation. Note absence of Synch switch control handle).

Note synch switch (above and to the left of CB 212 control switch with red and green lights) is missing the red control handle because it is in the CB 232 synch switch at the time these photographs were taken.

As noted by PG&E senior protection engineer Karchemskiy¹⁸ “Synch switches at the station are not keyed. This is serious violation of PG&E standard design. It allows paralleling of PT secondaries, which is abnormal”:
